Safe Anyway:

RAF Nimrod XV230 Crash over Afghanistan

Leadership ViTS Meeting

January 2012

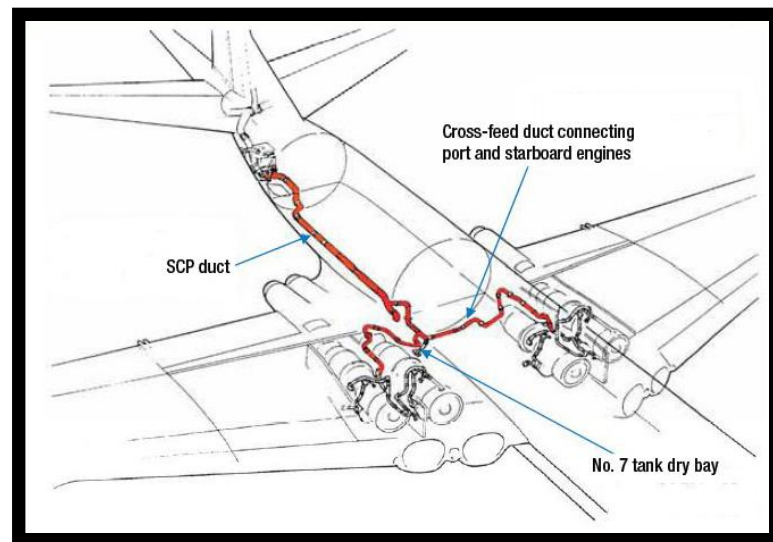
Figure 1: Nimrod schematic

Although enemy forces prevented the RAF from recovering most of XV230's wreckage, the Board of Inquiry (BOI) obtained enough material to determine that the explosion was the final event in a chain that began when jet fuel accumulated in the No. 7 dry bay. Fuel could have arrived in the dry bay in one of two ways: A) It ejected from the No.1 tank's blow-off valve during AAR, tracked back along the fuselage, and entered the dry bay through ports or intakes; or B) Fuel couplings in the dry bay failed, allowing fuel to escape from conduits in the dry bay and accumulate at the base of the compartment. Somehow this fuel contacted the extremely hot SCP duct and self-ignited. Without fire detection or suppression systems in the dry bay, the fire spread to the bomb and aileron bays before alarms alerted the crew to its existence. Eventually, heat from the fire caused fuel in tanks to boil, raising the tanks' internal pressure, causing them to explode and tear the aircraft apart.

- The cross-feed duct's placement among fuel and hydraulic lines contradicted good engineering practice because it placed a potential ignition source (the hot duct surface) in the vicinity of a potential fuel source (possible fuel leaks) without designating the area as a fire zone.

- Although Refrasil, a fluid-impermeable substance, covered the cross-feed duct, it deteriorated over time and was discontinuous in certain places.
- The addition of the SCP duct posed the same risks as the original cross-feed duct, and since it spanned the entire length of the No. 7 dry bay, it increased the area where an accident could occur.

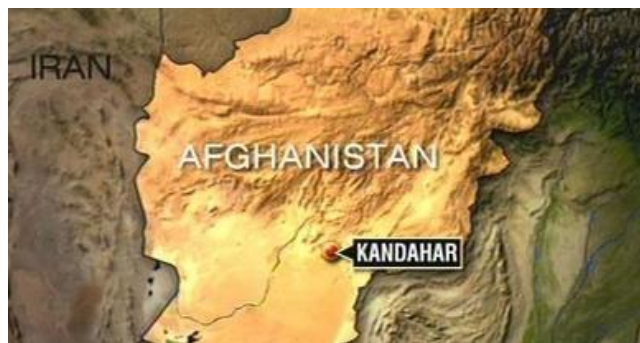
Figure 2: Nimrod XV230 crashed near Kandahar, Afghanistan.
Photo Credit: whdh.com
